Phase II Site Appraisal Rev1

Elmsleigh Road, Staines

Inland Homes PLC

L20002

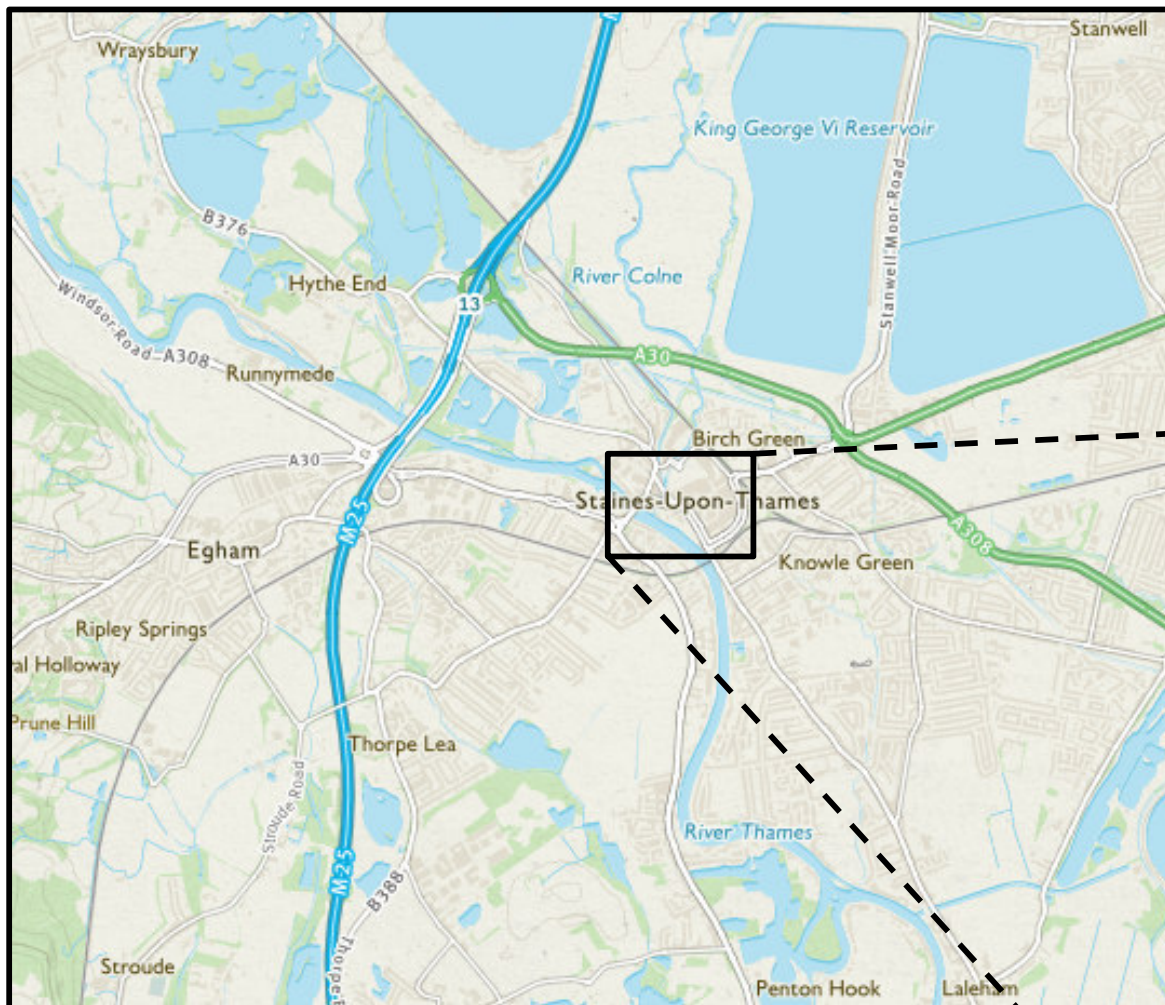
= Approximate
site boundary

40 St Pauls Square Jewellery Quarter Birmingham B3 1FQ T. +44 (0) 121 592 0000 E. info@patrickparsons.co.uk W. www.patrickparsons.co.uk	Client: Inland Homes PLC	Project No.: L20002	Scales: Not to scale	Issue: 0
	Project: Elmsleigh Road, Staines	Title: Site Location Plan	Design/drawn: HA	Checked: JPB
			Drawing no: L20002-701	Rev. 0

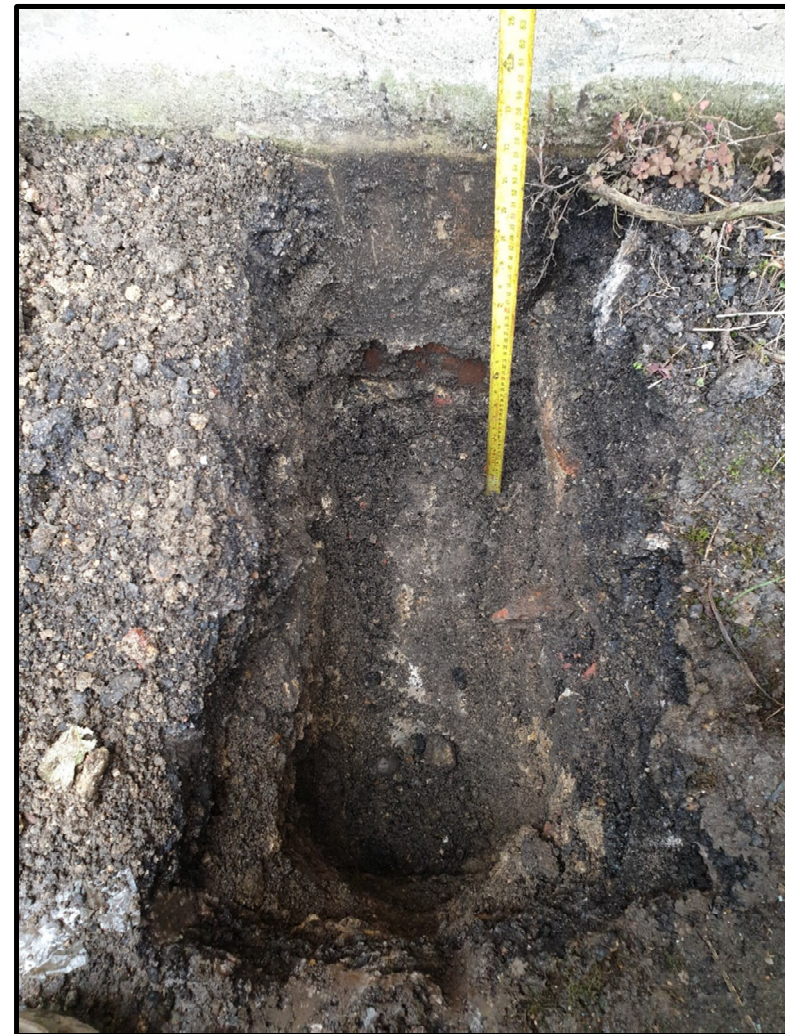
= Concrete Foundations

= Brick Foundations

Foundation Pit Location	Observed Foundation Width (m)	Foundation Maximum Depth (m)	Comments
TP01	0.40	0.60	None
TP02	0.35	0.75	None

Foundation cross sections have been included in Appendix B for reference.

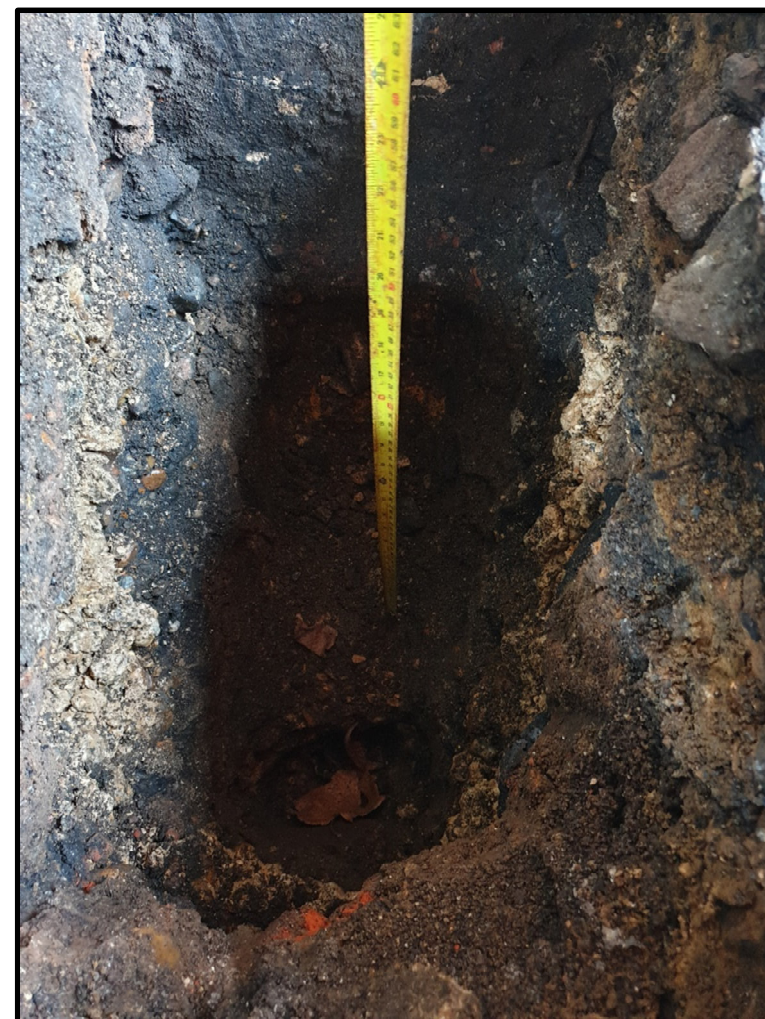
=

Concrete Foundations

Brick Foundations
